Safety Inspection Report

Annual Inspection

King George V Recreation Ground

Hurstbourne Tarrant Parish Council

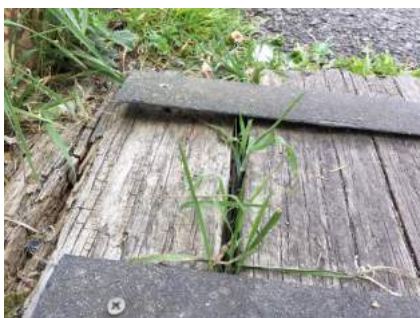
Fixtures loose or missing.

Tighten/replace.

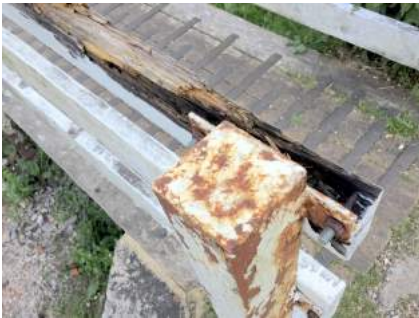
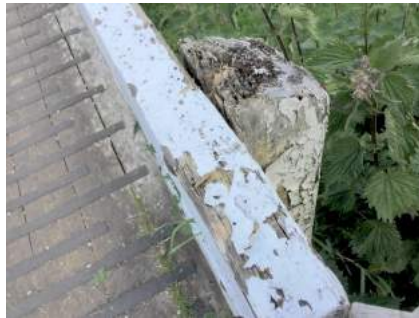
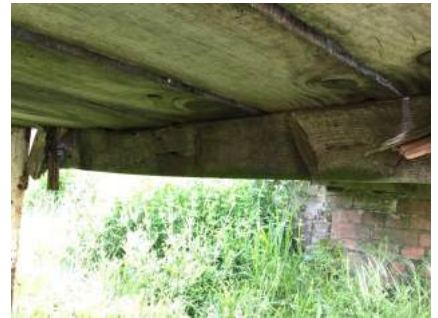
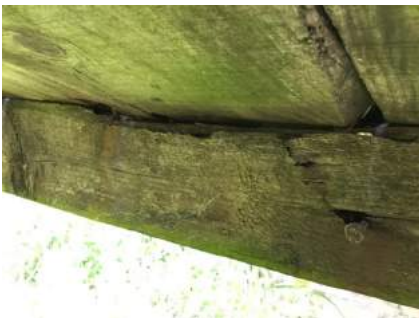
Timber is decayed.

Various pieces including supports under bridge showing severe signs of decay.

Replace affected parts.

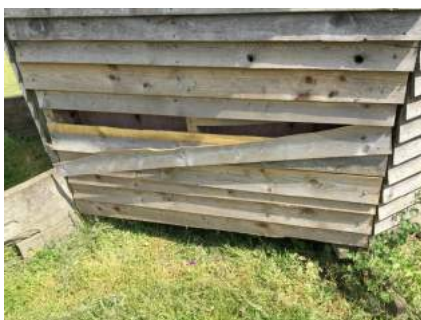
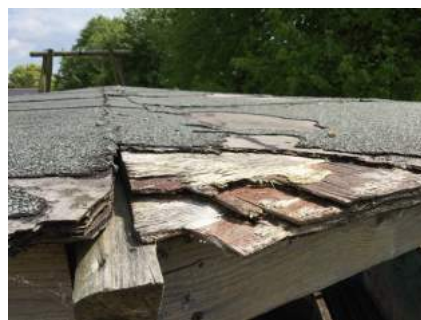
Item is damaged.

Repair.

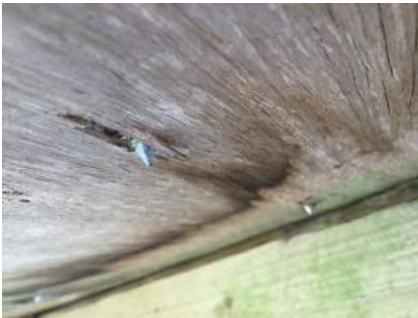
There are sharp edges or projections.

Nails projecting from the roof.

Remove the sharp/projecting parts.

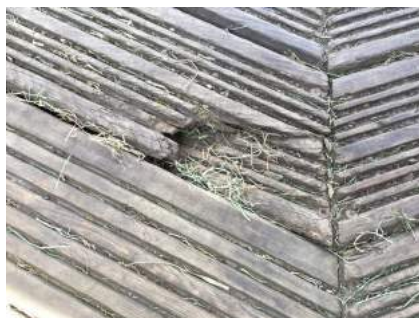
Timber is rotting.

Replace rotten timbers.

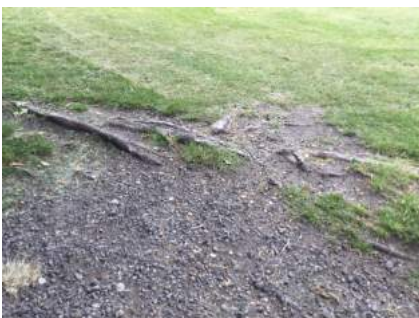
Trip points on the surface.

Tree roots becoming trip hazard - add more gravel / earth to eliminate risk.

Make level.

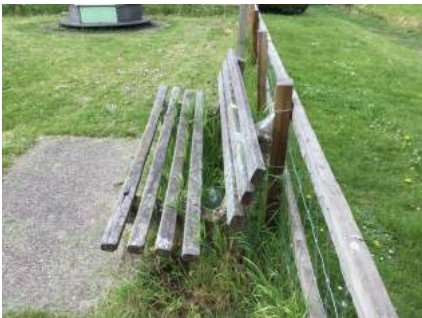
RoSPA recommend a minimum distance of 1 m between seat and fence. This is to reduce the likelihood of children vaulting the fence via the seat.

No reasonably practicable action is identified.

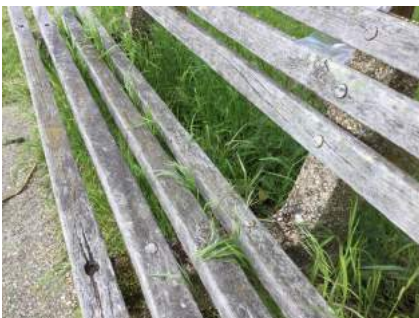
Timber is not in good condition.

Repair.

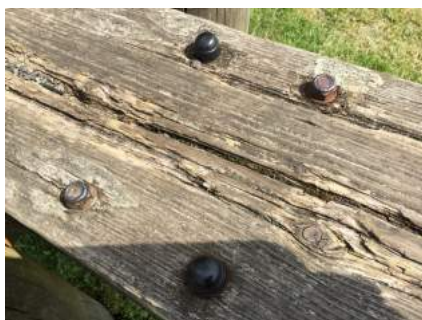
Cap missing.

Centre bolt.

Replace.

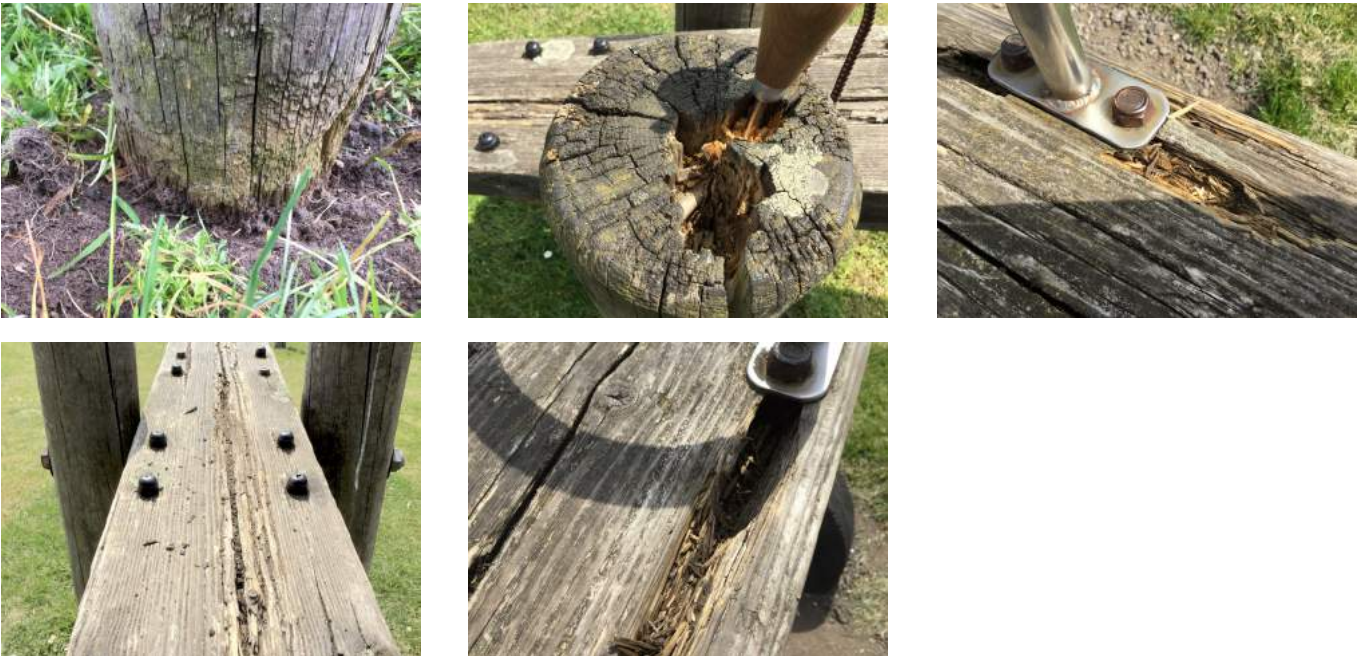
There is decay to timber components which may affect structural integrity. We do not recommend replacing rotten supports with timber posts which are directly set in the ground due to the increased problem of timber rot, especially in posts in contact with the ground.

Main support and plank.

Replace decayed components where possible and plan replacement of item. Check on a routine basis, especially at ground or foundation level.

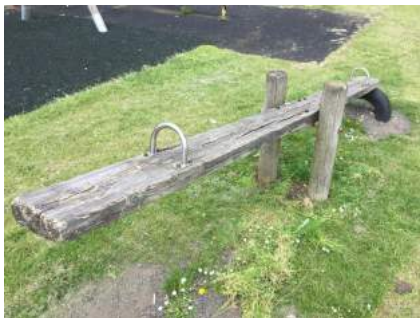
Item is at the end of its useful working life.

This item is very close to the end of its useful working life. Significant repairs must be made to much of the structure to prolong its life.

Read the notes for further action.

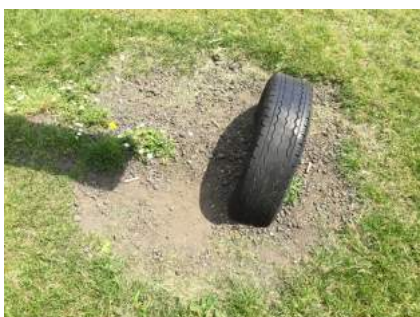
Ground erosion present.

Repair the worn areas.

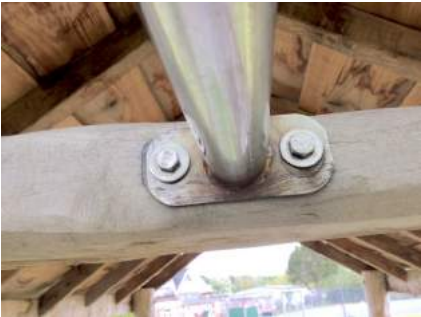
Fixtures loose or missing.

Tighten/replace.

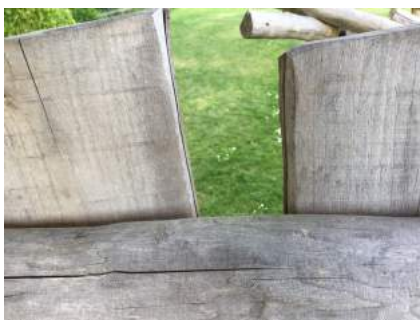
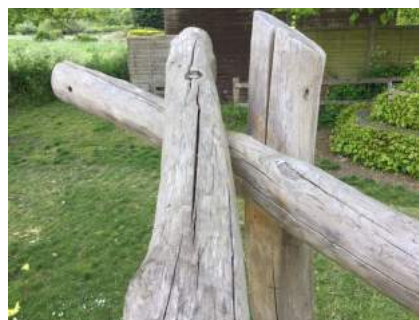
This unit is attractive, well put together, and should provide excellent play value for many years. While there are some standards failures and entrapments, the risks are manageable - monitor use.

See the notes.

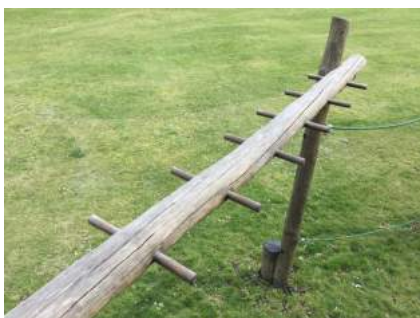
RoSPA is concerned by accidents on some types of overhead ladders and rings. However, there is a strong development value in these items.

The protective surface under all bars and rings must be kept in good condition.

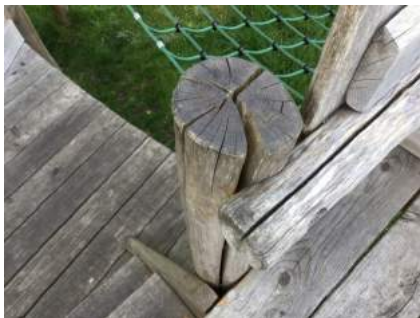
There are natural splits / shakes in the timbers.

Shakes vary. Monitor and consult manufacturer if dimensions exceed 8 mm at sections used to grip / grasp.

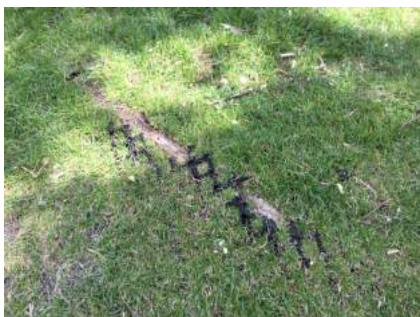
Surface needs repair.

Tree root has damaged surface within the impact area.

Repair.

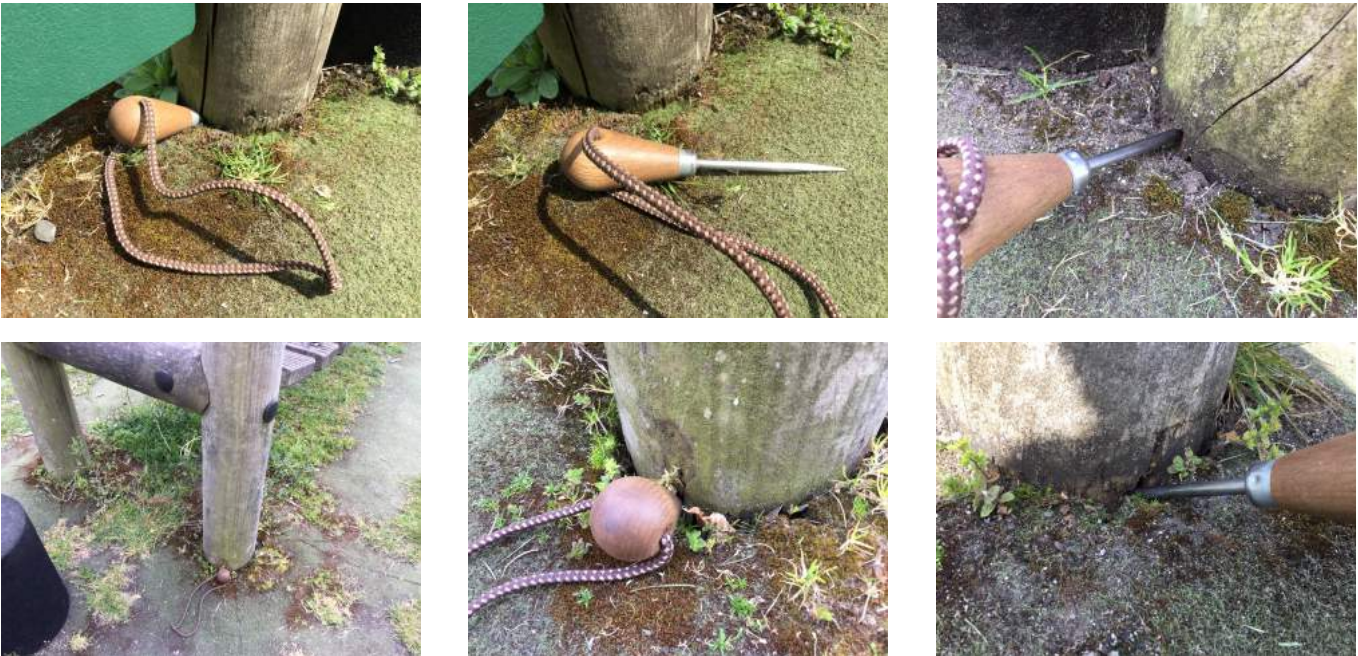
There is decay to timber components which may affect structural integrity. We do not recommend replacing rotten supports with timber posts which are directly set in the ground due to the increased problem of timber rot, especially in posts in contact with the ground.

Significant decay throughout the trail. Affected posts must be replaced.

Replace decayed components where possible and plan replacement of item. Check on a routine basis, especially at ground or foundation level.

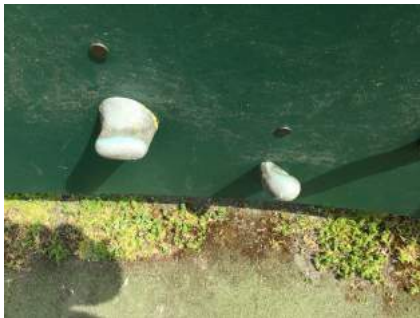
Fixtures loose or missing.

Climbing grips loose - monitor and tighten as needed.

Tighten/replace.

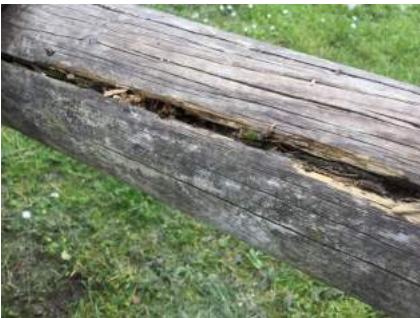
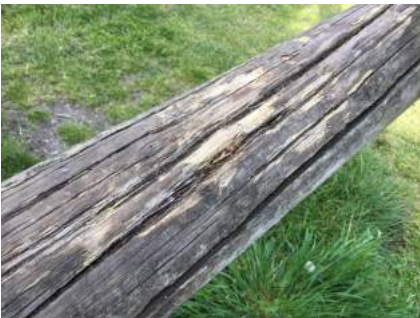
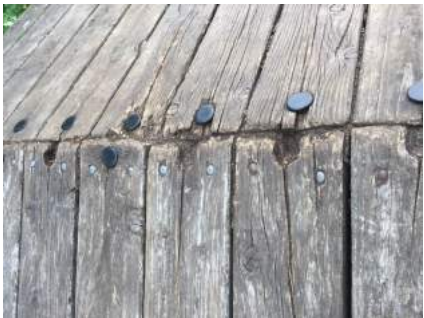
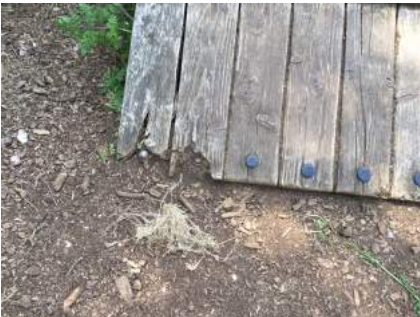
There is decay to timber components which may affect structural integrity. We do not recommend replacing rotten supports with timber posts which are directly set in the ground due to the increased problem of timber rot, especially in posts in contact with the ground.

Replace decayed components where possible and plan replacement of item. Check on a routine basis, especially at ground or foundation level.

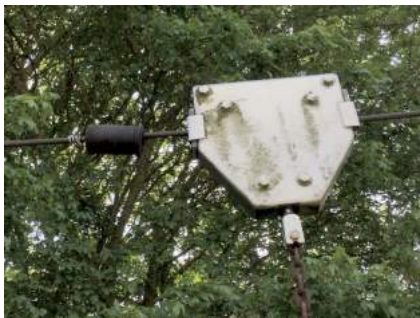
The supporting components should be dismantled and inspected according to the manufacturer's instructions. This will need doing on a regular basis.

Dismantle and inspect according to manufacturer's instructions.

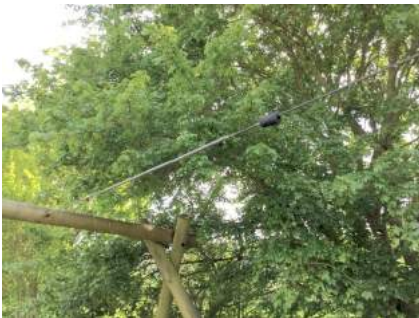
Item broken.

Cable stop spring.

Replace.

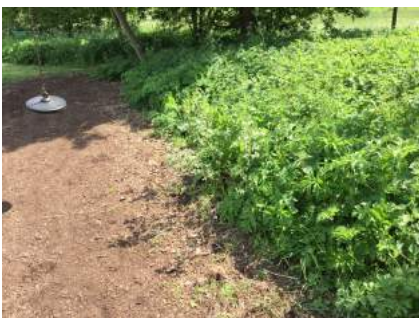
Excessive weed growth on surfacing.

Mechanical removal is recommended.

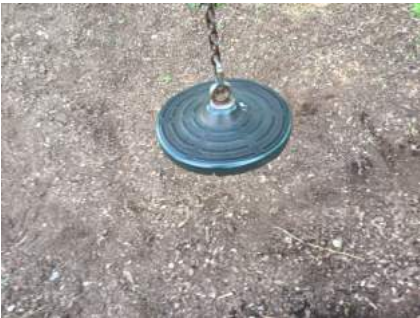
It is considered that the runway will have insufficient ground clearance under seat.

Modify to give a minimum 400 mm clearance under load.

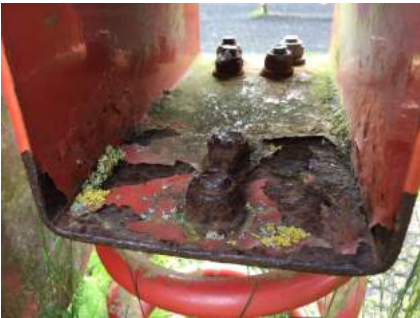
There is significant corrosion on this item.

De-scale back to good metal and coat with lead free paint, using appropriate precautions. Repairs may be necessary where corrosion is severe.

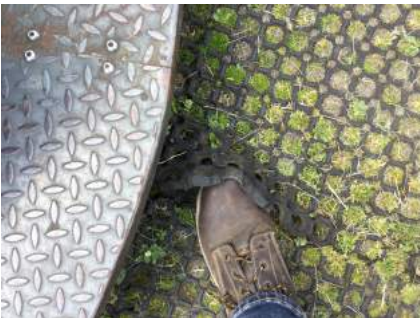
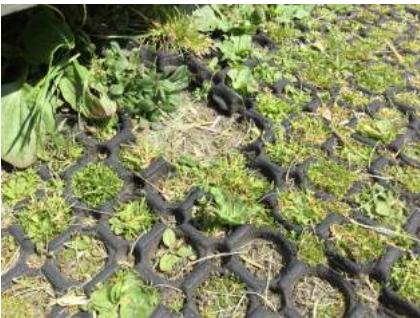
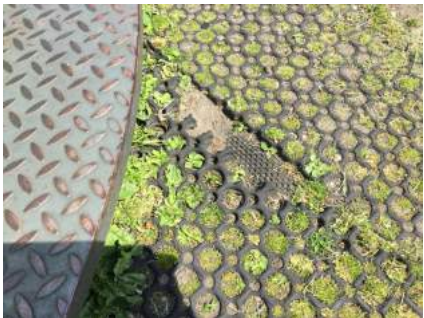
Trip points on the surface.

Surface requires various repairs.

Remove trip points.

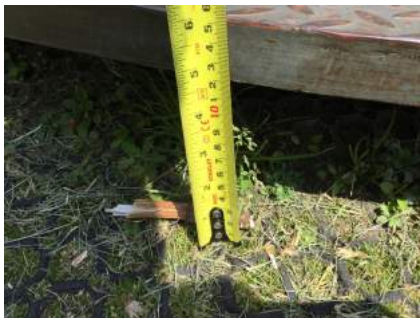
Carousel where the ground clearance is over 110 mm must have a continuous smooth surface.

No reasonably practicable action is identified.

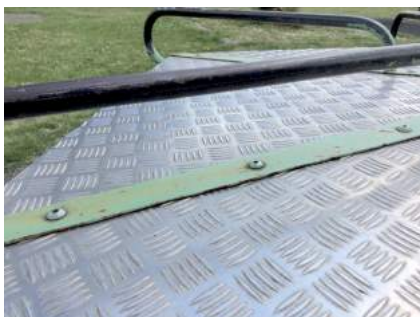
There is a head entrapment.

Hand rails.

No reasonably practicable action is identified.

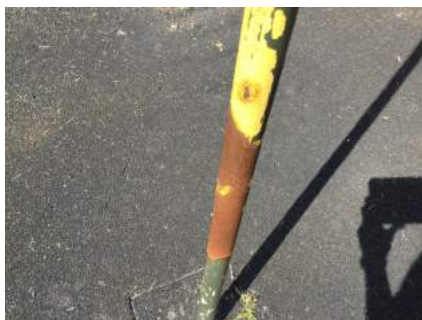
Paintwork is in poor condition.

De-scale back to good base material and coat with lead free paint, using appropriate precautions. Repairs may be necessary where corrosion is severe.

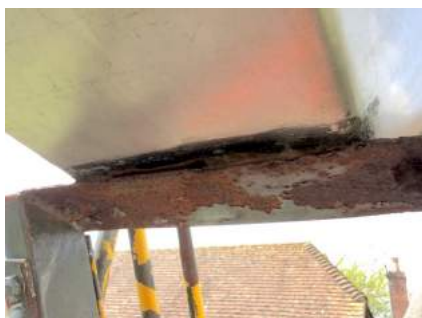
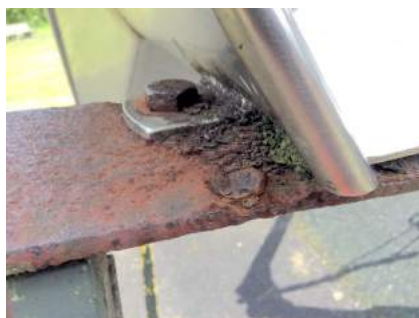
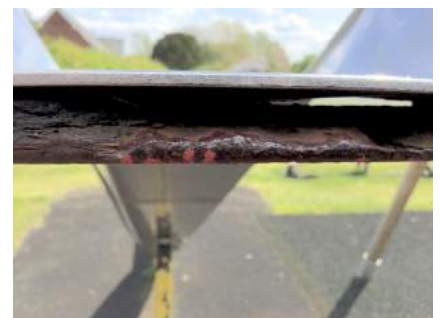
There is significant corrosion on this item.

Repair.

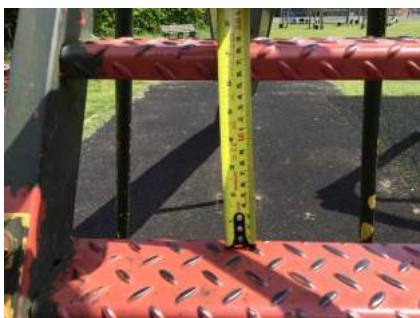
Access fails entrapment requirements.
