Safety Inspection Report

Annual Inspection

King George V Recreation Ground

Hurstbourne Tarrant Parish Council

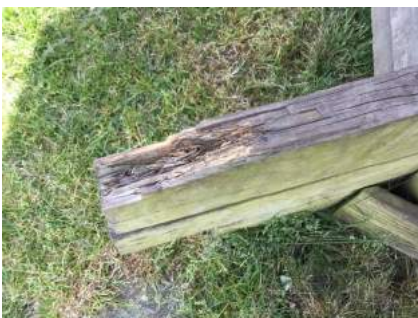
Replace rotten timbers.

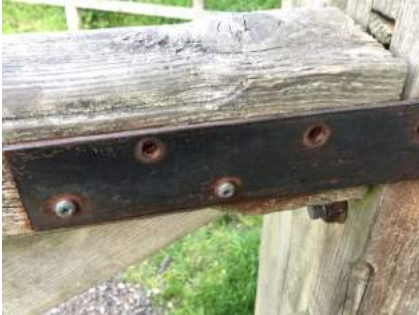
Fixtures loose or missing.

Tighten/replace.

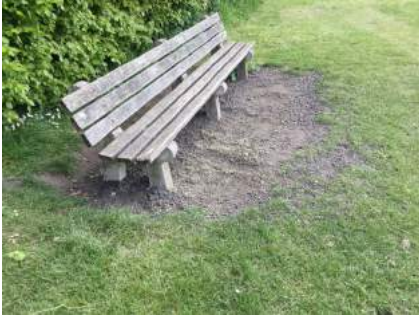
Surface is wearing.

Repair.

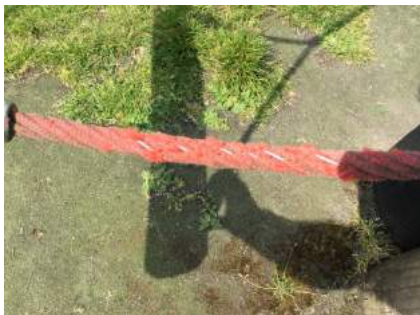
Replace the worn ropes.

Wrap and monitor while preparing to replace.

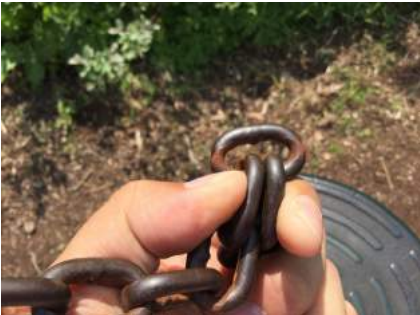
Some chain wear.

Monitor for further deterioration and replace before 40% wear.

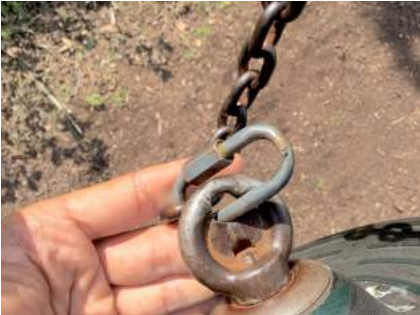
Chain link connectors worn.

Replace worn parts.

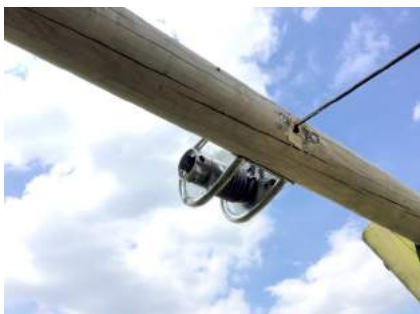
Where the cable enters into a tube, top bar or similar it is not possible to determine its condition, therefore this is excluded from our inspection. It is vital that the operator arranges to dismantle the unit to inspect the full length of the cable for any corrosion, wear or damage.

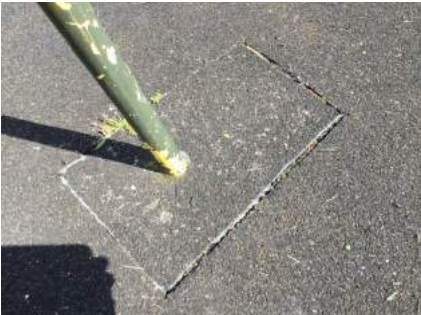
Shrinkage / separation of the surface. This may give a trip hazard.
